# Manhole Inspection Summary

Manhole # S1900\_021MH

Insp Date: **12/16/08 12:20 PM**

**Location** Address: **2325 REISTERSTOWN RD**

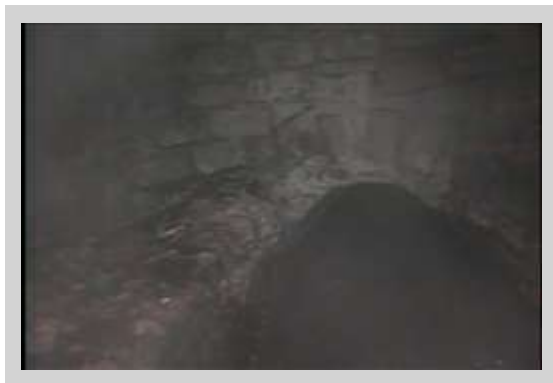
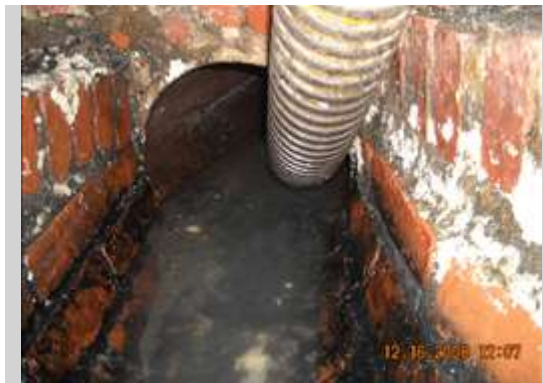
Pipe Out @ 12 O'Clock

12 in. Circular Gravity Sewer

12 O'Clock Outflow

Infiltration: **None** Pipe Seal Cond: **Sound**

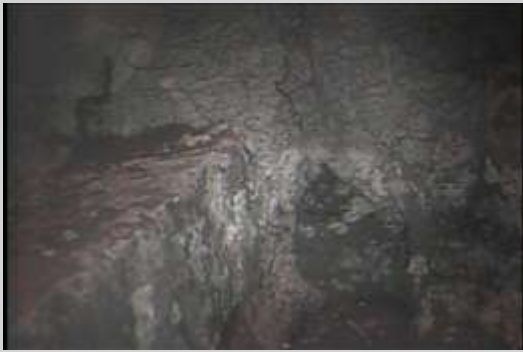
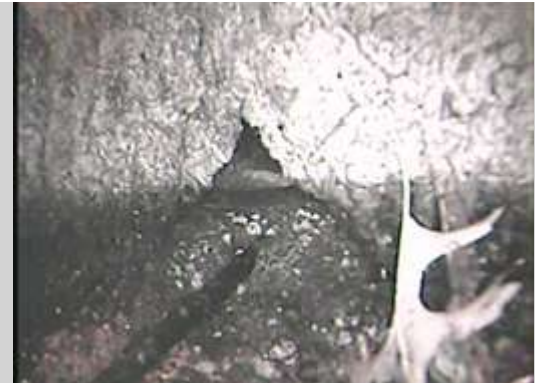
Pipe In @ 4 O'Clock

10 in. Circular Gravity Sewer

4 O'Clock Inflow

Drop: <b>Inside</b>	Rod and Bar
Angled: <b>Yes</b>	Reading: <b>11.30</b> (ft.)
	Inv Depth: <b>12.30</b> (ft.)
Drop Condition: <b>Partly Clogged</b>

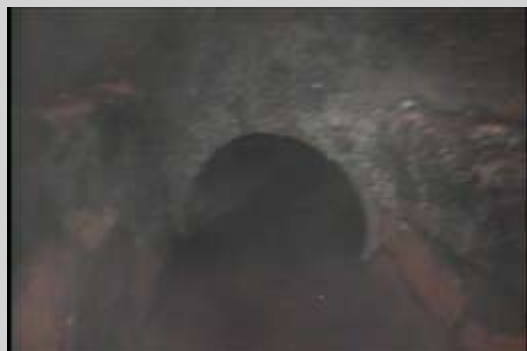
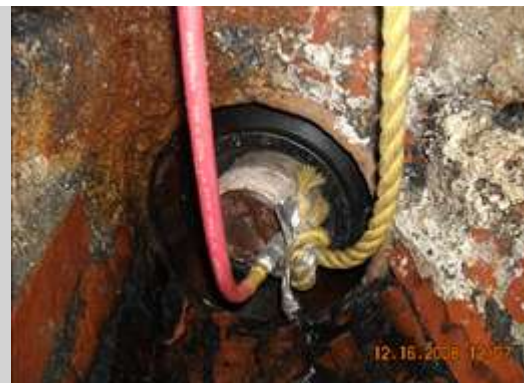
Pipe In @ 7 O'Clock

10 in. Circular Gravity Sewer

7 O'Clock Inflow

Infiltration: None Pipe Seal Cond: Sound
